DRAFT REPORT

Building Enclosure Forensic Investigation

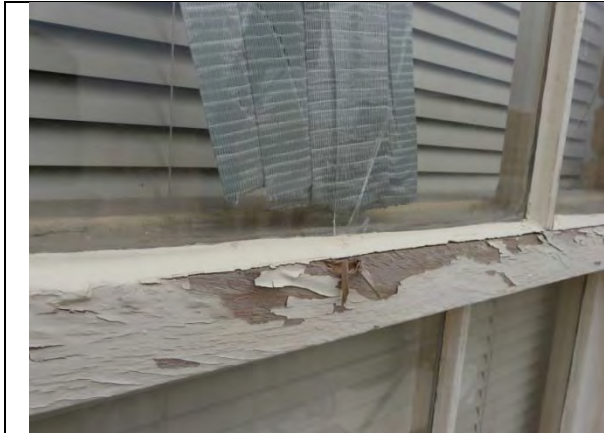
1. An unusual impact signature at the meeting rail, with forces transferred via its glazing compound to the glass pane, resulting in its stress breakage. The peeling coating is a preexisting condition. Window #60, 12/17/2014

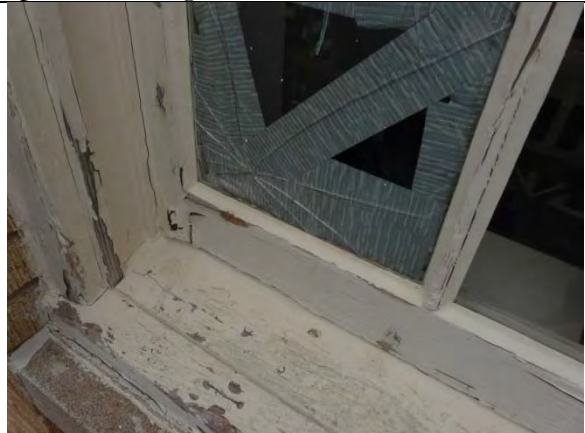
2. Typical impact signature to the bottom rail and glass, resulting in simultaneous direct impact breakage of glass pane and indentation of wood, which gives an idea of the size of the hailstone. Also, the indentation of the wooden sill and its coating is visible below. The peeling coating is a preexisting condition. Window #65, 12/17/2014

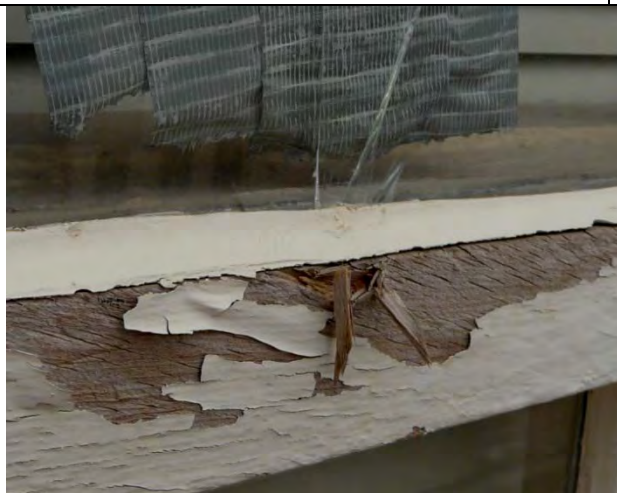
3. Close up of the photo reproduced above, focusing on the meeting rail damage. Window #60, 12/17/2014

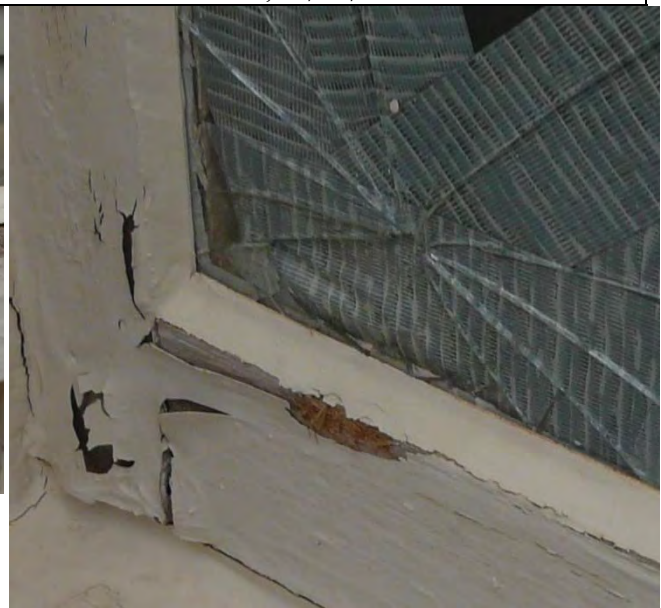
4. Close up of the photo reproduced above, focusing on the bottom rail damage. Window #65, 12/17/2014

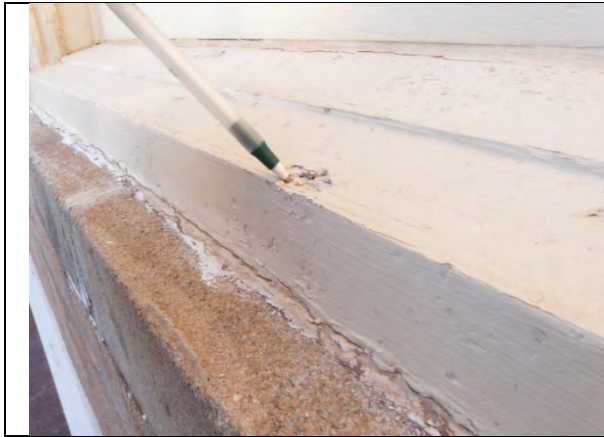
5. One of the deepest observed dents at the window sills, resulting from a hailstone impact .
Window #99, 12/18/2014

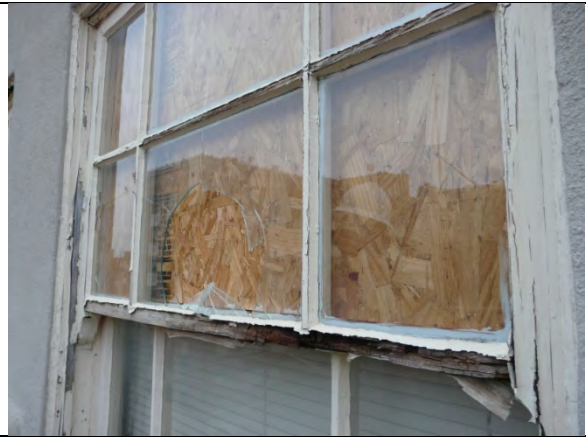
6. Glass breakage of an upper sash, with glass panes deadloaded on a rotten meeting rail. Wood rot and loss of coating are preexisting conditions. However, this member may need to be restored in order to reglaze the window. Window #5, 12/17/2014
