DRAFT REPORT

Building Enclosure Forensic Investigation

RE: **Document Type: Invest – Site Investigation**

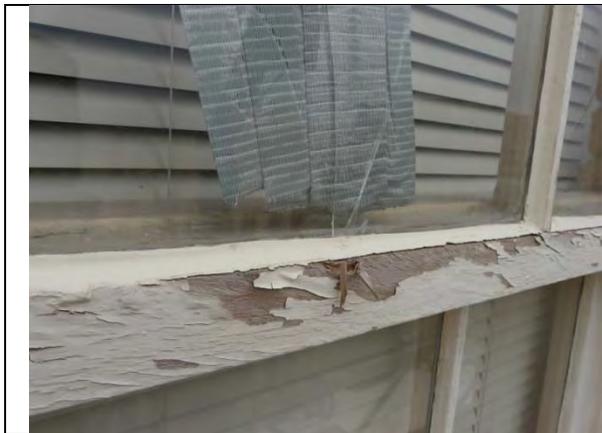
- a. Glass breakage. We noted some windows glass to be cracked, and some glass fragments to be missing. There were glass shards remaining on the adjacent surfaces, which had originally been a part of glazing located above. Some affected panes were observed boarded with OSB sheets, and some cracks were taped with a duct tape, while others were not. We noted the pattern of temporary repairs was not always consistent with glass damage (some unbroken glass was observed to be taped, and some broken glass was observed to be not). We also noted breakage of several glass bricks. We generally divided glass breakage into stress and impact breakage, which is normally a baseline for causation assessment of an impact-generating peril. Majority of the glass exhibited impact signature. Several panes were observed to exhibit stress crack signature, inconsistent with hail impact; however, all except three of these cases were tracked to a hail impact sustained by adjacent opaque components, and the forces of impact indirectly transferred and stressed the broken glass edge. We refer the interested reader to photographs #1 and #3 in Appendix "D."

1. An unusual impact signature at the meeting rail, with forces transferred via its glazing compound to the glass pane, resulting in its stress breakage. The peeling coating is a preexisting condition. Window #60, 12/17/2014

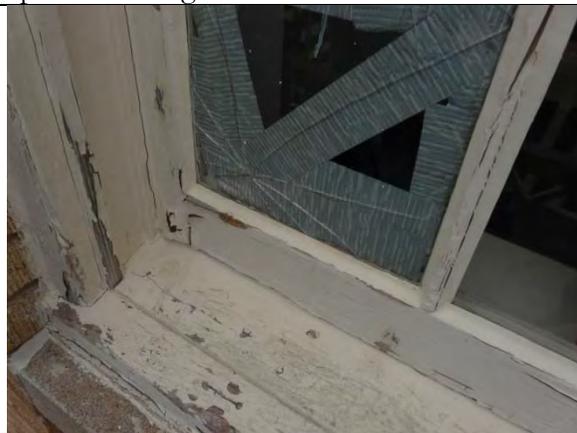
2. Typical impact signature to the bottom rail and glass, resulting in simultaneous direct impact breakage of glass pane and indentation of wood, which gives an idea of the size of the hailstone. Also, the indentation of the wooden sill and its coating is visible below. The peeling coating is a preexisting condition. Window #65, 12/17/2014

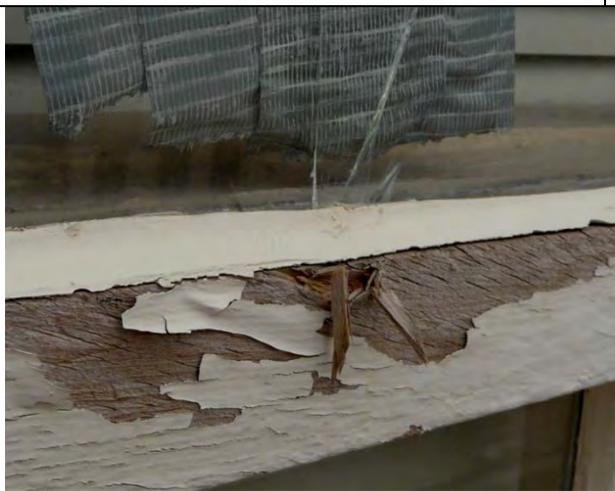
3. Close up of the photo reproduced above, focusing on the meeting rail damage. Window #60, 12/17/2014

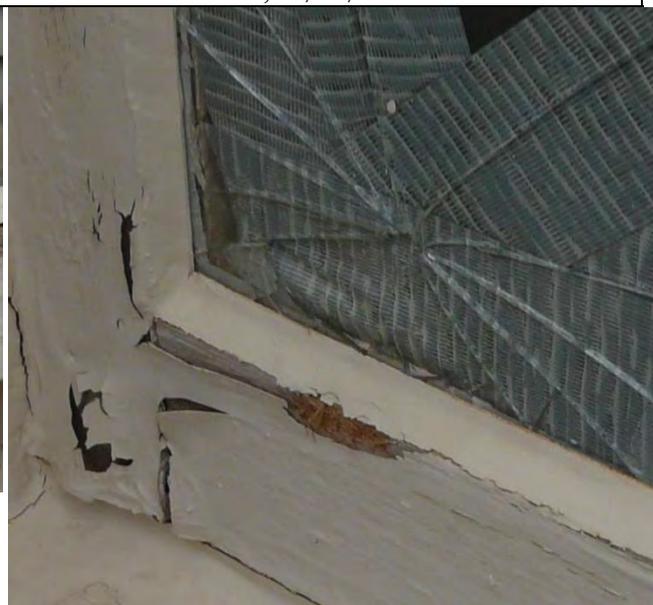
4. Close up of the photo reproduced above, focusing on the bottom rail damage. Window #65, 12/17/2014

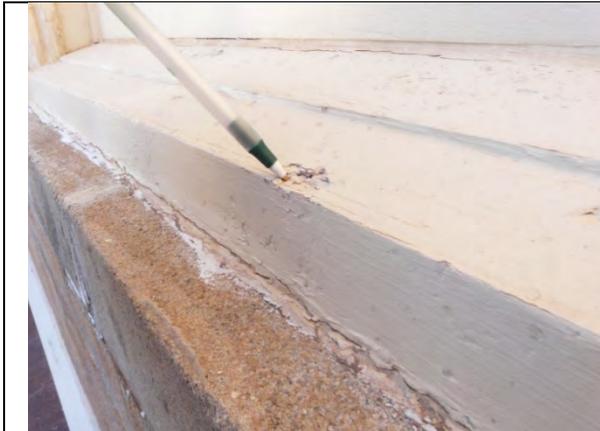
5. One of the deepest observed dents at the window sills, resulting from a hailstone impact .
Window #99, 12/18/2014

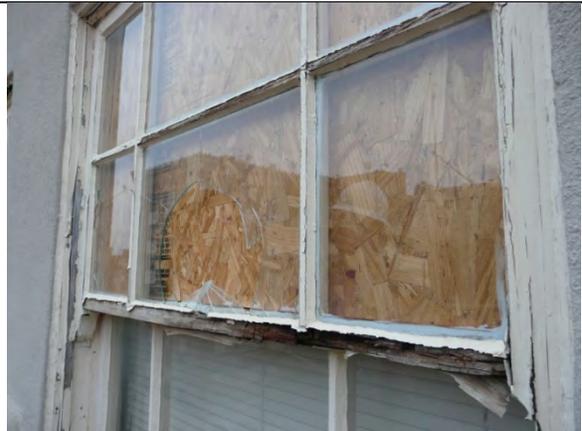
6. Glass breakage of an upper sash, with glass panes deadloaded on a rotten meeting rail. Wood rot and loss of coating are preexisting conditions. However, this member may need to be restored in order to reglaze the window. Window #5, 12/17/2014

Recommendations: Refurbishment recommendations are outside our scope. However, several units will require partial refurbishment in order to perform a repair: i.e. replacement of those

damaged glass panes which are supported by rotten rails, would be impossible without replacing the rotten members first. We refer the interested reader to photograph #6 in Appendix "D."
