REPORT

Building Enclosure Maintenance Review

for the [REDACTED] building complex located in
[REDACTED]

March 21, 2016

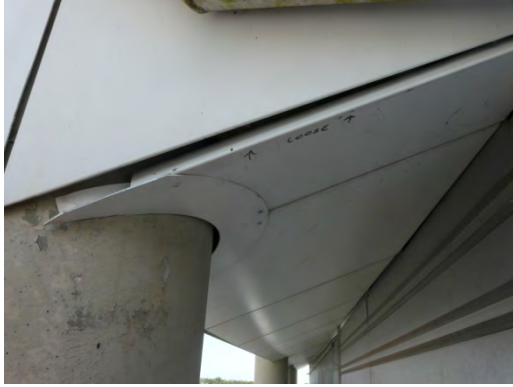
Photo #1930508. Soffit panel visibly sagging and showing excessive deflection when touched by hand.

Recommendations: Repair preceded by engineering evaluation of the areas that show indications of inconsistent installation. Loose and insufficiently attached components may need to be temporarily removed and secured, and the areas fenced from access for safety.

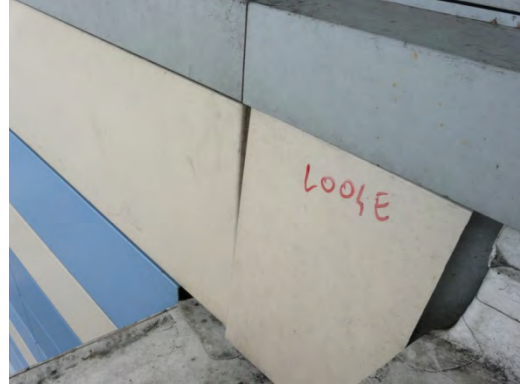
Photo #191001. Wall panel visibly misaligned and showing excessive deflection when touched by hand.

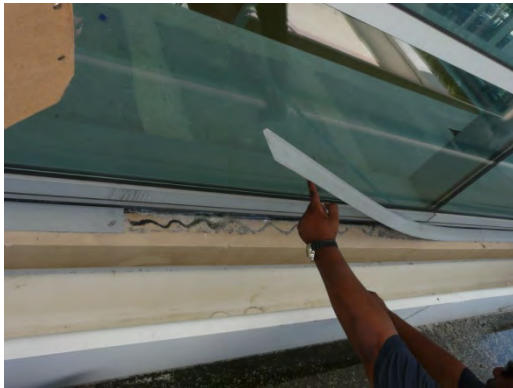
Photo #1920264. Sill trim panel visibly misaligned and showing excessive deflection when touched by hand.

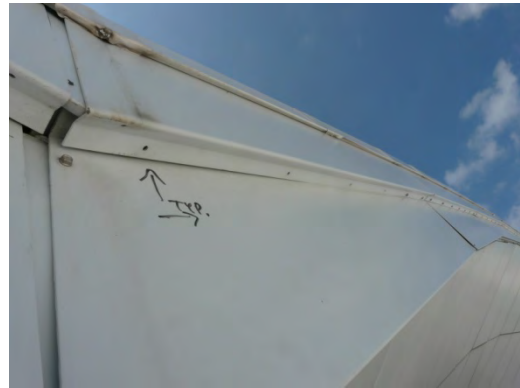
Photo #1930858. Roof fascia panel missing fasteners.

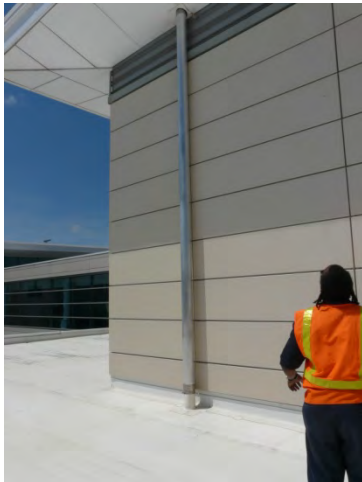
Deficiency: We noted 23 separate instances of insufficient support of downspout pipes. The most typical support consists of a single friction fit clamp. Pipes are typically connected by rubber sleeves, which in some instances constitute the entire support. Some clamp bolts were observed rusted.

Photo #1920214. A 20 ft. long downspout pipe missing support.

Recommendations: Retrofit preceded by engineering calculations. Engineer and produce attachments with a continuous and redundant resistance path to the building structure.

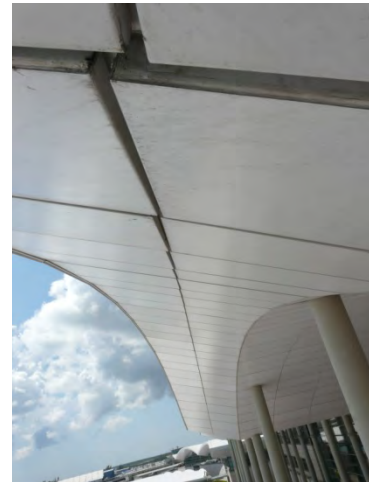
Photo #193044. Soffit panels visibly misaligned.

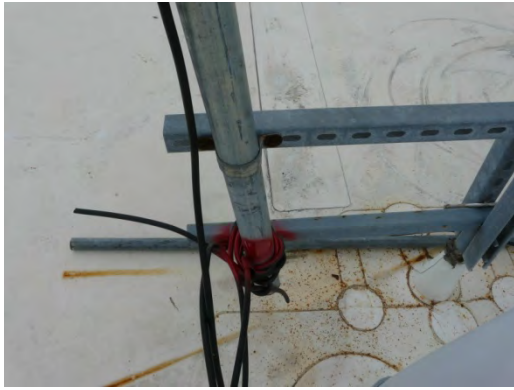
Photo #1920476. Rusted non-redundant connection of a loose antenna mast. Second connection provided with a tied cable.

Recommendations: Cleanup. Engineer and produce antennae attachments with a continuous and redundant uplift resistance path to the building structure. Net the patios to contain rubbish.

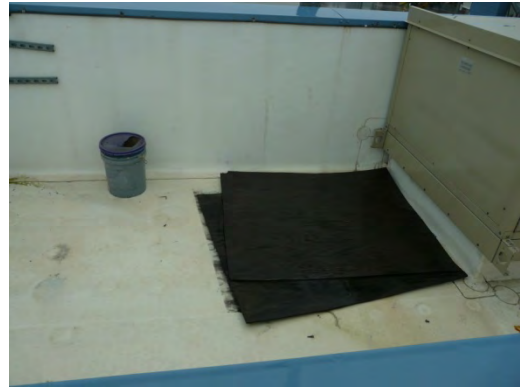
Deficiency: We noted 64 separate instances of intentionally loose items, such as debris and rubbish, ranging in size from large antenna racks, buckets, pipes, and plywood sheets, to rocks, small steels shavings and fasteners.

Photo #1900876. Construction debris remaining on roofs: bucket and plywood sheets

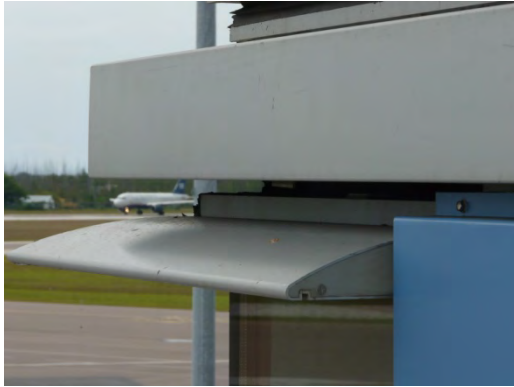
Deficiency: We noted 22 separate instances of failed and missing primary seals. We also noted cool areas, indicating a concealed primary seal breach.

Photo #1910365. Missing primary sealant joint at curtain wall head.

Recommendations: Re-seal. Most primary joints are concealed from view, and therefore would need to be located by pressurization testing.

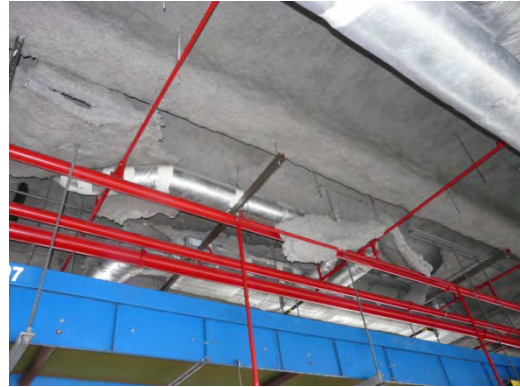
Deficiency: Fragments of insulation have collapsed since the time of construction.

Photo #1900520. Collapsing overhead thermal insulation.

Recommendations: Remove and replace.

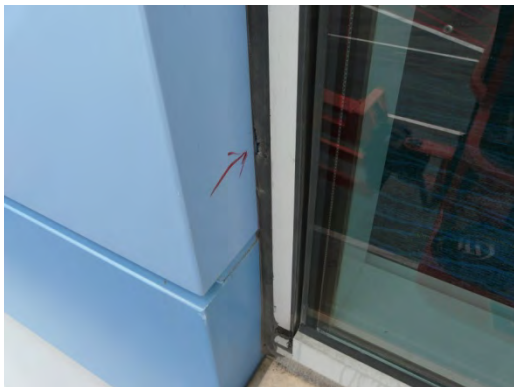
Deficiency: We noted 60 separate instances of failed and missing secondary seals.

Photo #1910144. Secondary jamb sealant failure.

Recommendations: Sandblast, galvanize, and coat. Re-seal as needed.

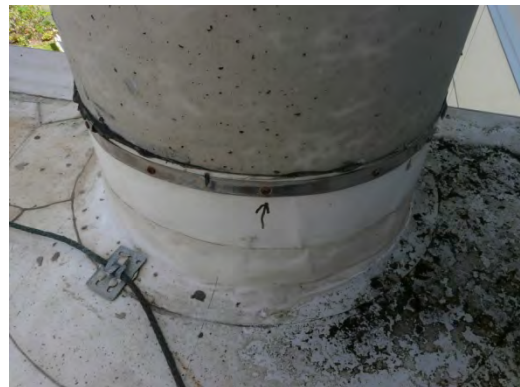
Photo #193051. Unsealed roofing termination.

Recommendations: Repair.

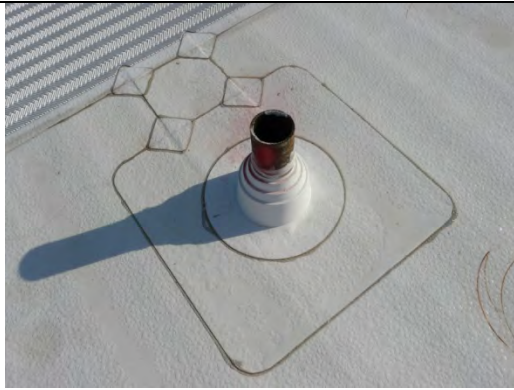
Deficiency: We noted 257 separate instances of rusted components, with some of them affecting seal substrates.

Photo #1910855. Rusty vent stack.

Recommendations: Sandblast, galvanize, and coat. Re-seal as needed.

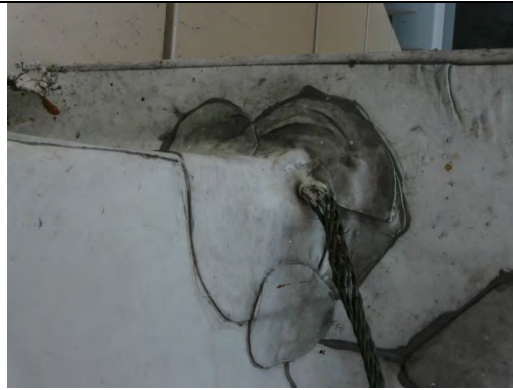
Deficiency: We noted 74 separate instances of improper details.

Photo #1900075. Improperly detailed, unsealed roofing termination.

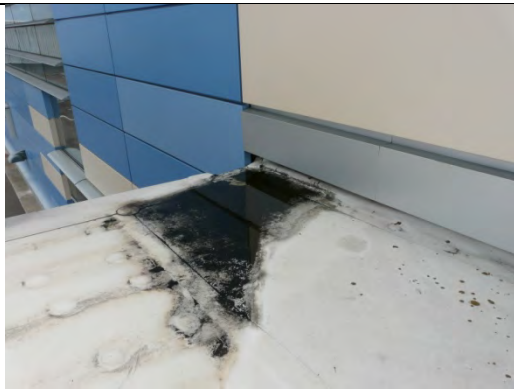
Deficiency: We noted 44 water pools, with indication of prolonged water exposure.

Photo #1910090. Standing water on roof. Water discharging into wall.

Recommendations: In a long term, these areas should be re-roofed in order to provide a positive slope. They may require additional covering as a preventative measure, because these areas will wear first.

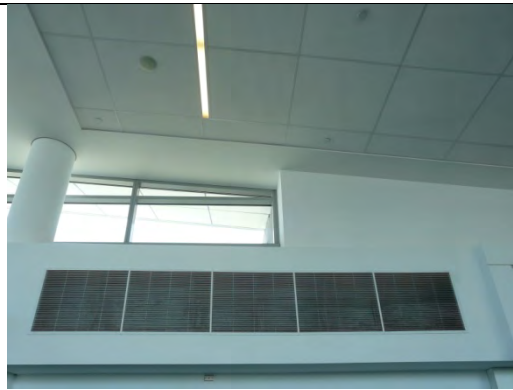
Description: Leak was painted over before our arrival.

Deficiency: There are several visible deficiencies above this location, including open gaps in metal cladding, with bare sheathing visible from the exterior. We refer the interested reader to the spreadsheet and photographs.

Photo #1930329. Leak above soda machine near [REDACTED].

Recommendations: If the leak persists after the visible weatherproofing deficiencies were repaired, a leak investigation would be necessary.

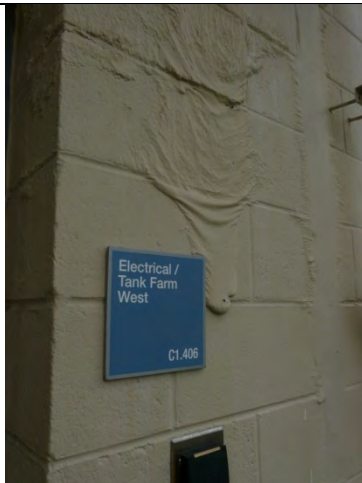
Deficiency: Spectacular efflorescence and blistering, due to water entering the wall at the top.

Photo #1920765. Blistering of elastomeric coating.

Recommendations: Install a through-wall flashing or remove the coating.

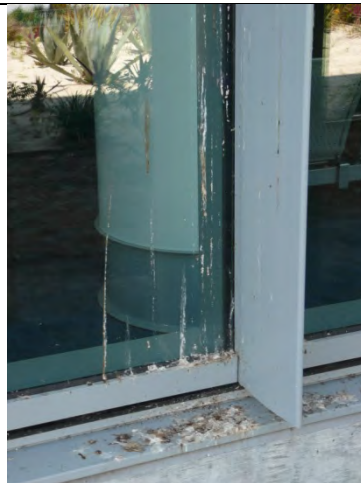
Deficiency: We found 10 nests, and noted some areas where wildlife became a nuisance. Examples are bird droppings on patios and curtain walls, and bird carcasses.

Photo #1890415. Bird deposits on a curtain wall near the rest area.

Recommendations: Bird deterrents. Installation of bird nets and spikes.
