REPORT

**In-Situ Solar Heat Gain  
Coefficient (SHGC)  
Determination  
for Curtain Wall Glazing**

**[REDACTED] Tower**

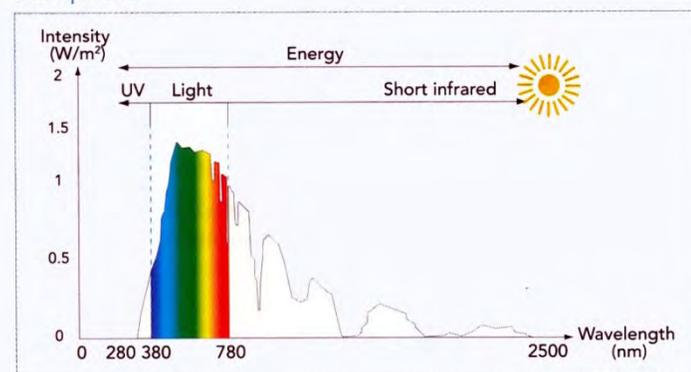
Solar spectrum

According to the European Standard EN ISO 410 cited by American NFRC standards, SHGC is the glass transmittance in range from 300nm to 2500nm, as shown on the chart below. This range embraces ultraviolet (UV) rays, visible (VIS) range, and near-infrared (NIR) range called also “solar range,” or “short infrared.

Type of radiation	Wavelength (nm)	Proportion of energy
UV	280 to 380	approx. 5 %
Visible	380 to 780	approx. 50 %
IR	780 to 2,500	approx. 45 %

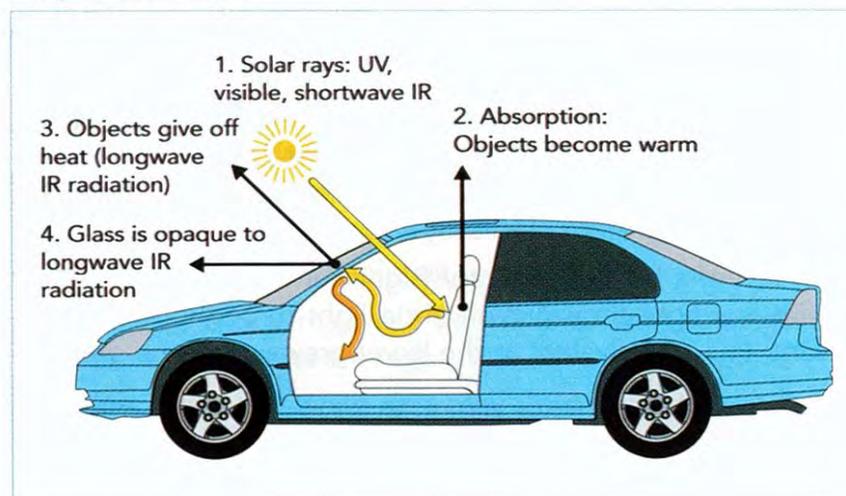
The greenhouse effect

In the context of the situation at hand, human body generally cannot directly and instantaneously detect solar radiation other than the visual (VIS) light range, but the near-infrared NIR radiation is absorbed by objects such as human skin and re-radiated in the thermal range which we can feel as heat.

This phenomena contributes to “greenhouse” effect. An example a car windshield below illustrates such condition.

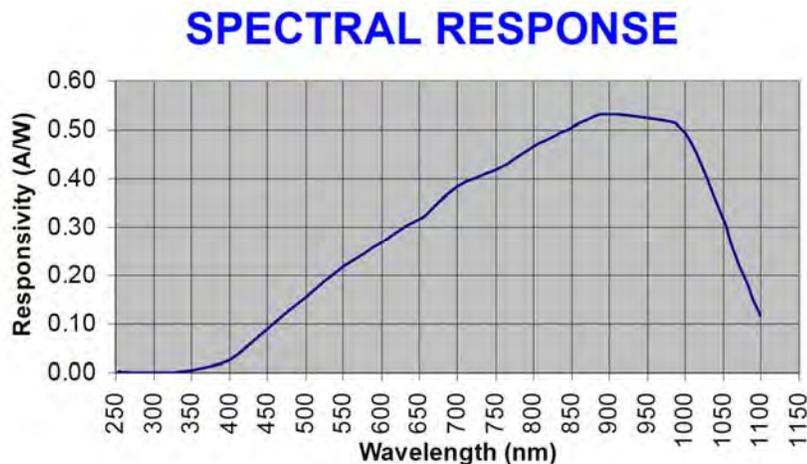
So, we developed and built two identical solar cell pyranometers, based on the modified design of Mr. [REDACTED], PhD of [REDACTED] in [REDACTED]. Two silicon photodetectors [REDACTED] loaded with 470-Ohm resistors, were employed and installed in plastic tubes with 1 mm (0.039") thick x 3/8" diameter Teflon® disks placed at the front. The spectral response of the photodetectors is in range of 300-1100nm, as shown in the chart below.

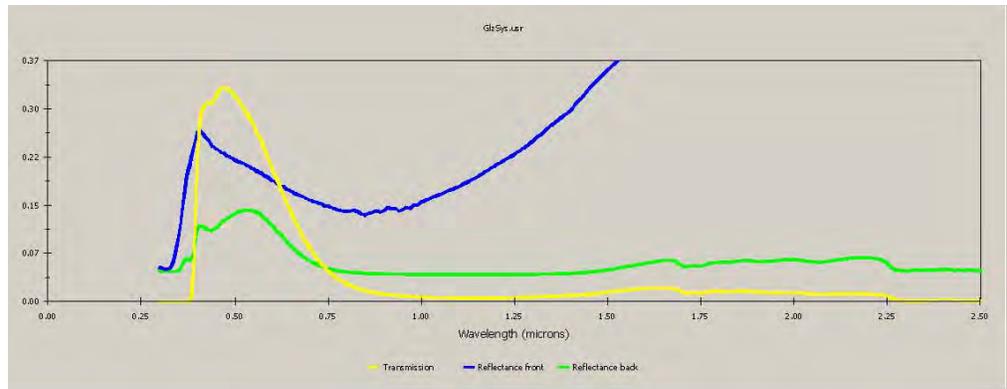
simulated the glass spectral response in Optics software by Lawrence Berkeley National Laboratory. The result is presented in the chart below.

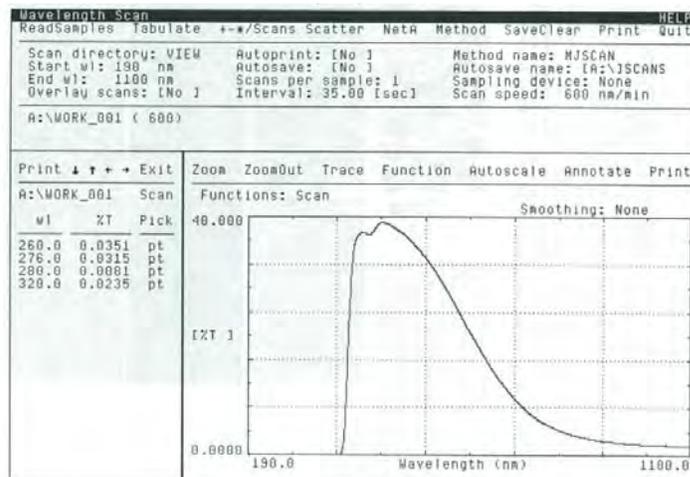
The glass samples were tested by a spectrophotometer Beckman DU 640 in range 180-1100nm and the result is presented below. Both charts are identical, with the characteristic double peak signature; therefore, we believe the glass we received is the glass specified. Flipping the glass produced an identical chart.

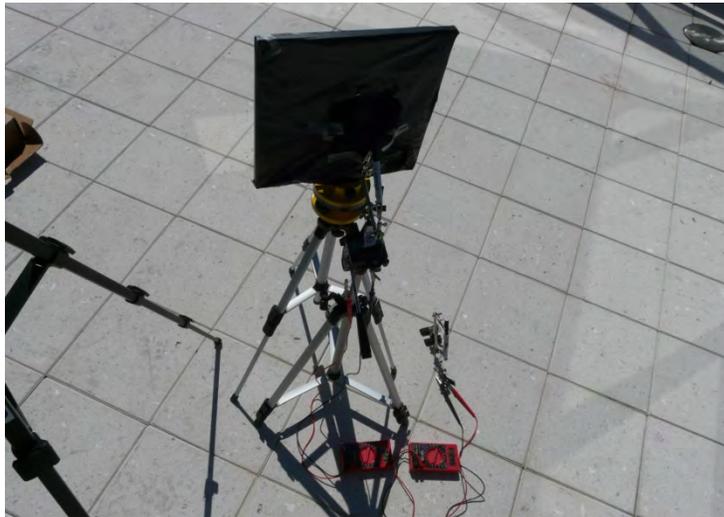
Subsequently, we noted the readings produced from our apparatus on the reference samples. We covered the entire sample with a black cover, leaving only a small hole for sunlight to get through, thus eliminating possible stray light reaching sensors. The pyranometers indicated 25/245 (10%) and pyrometer indicated 106/458 (23%).

Figure 6. The measurement of the reference sample on the 35<sup>th</sup> floor. The pyranometers read 245 (sensor in direct sun) and 25 (sensor sees the sun via the reference sample).

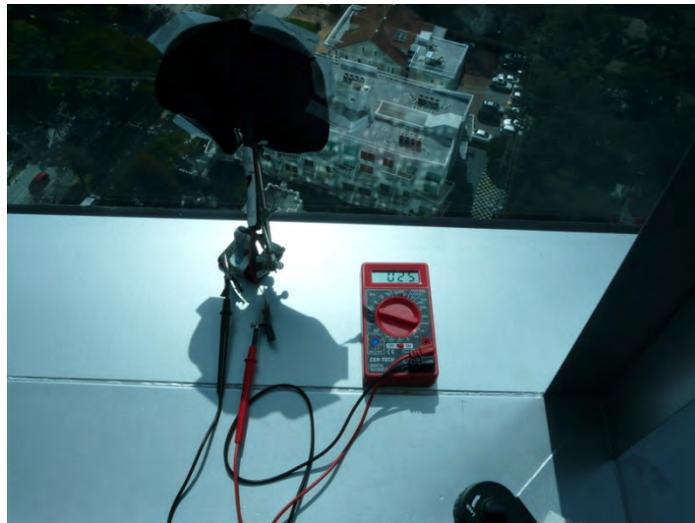
Figure 7. The pyranometer measuring the glass pane #2 in suite # █.

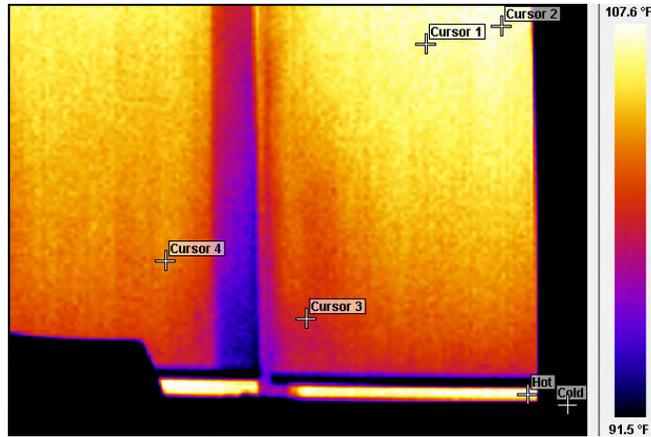
Figure 10. The suite # [REDACTED] at 10:20am on [REDACTED]. Fragment of the photograph above in the long IR range. Temperature of the shade is approximately 100 °F.

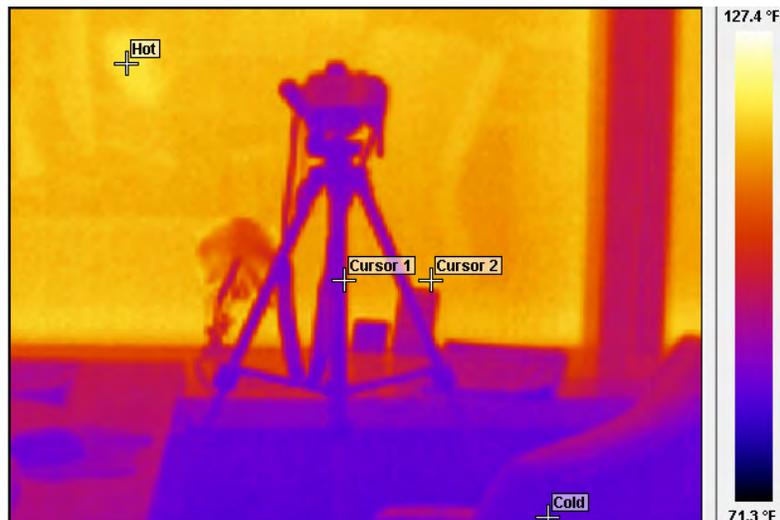
Figure 11. The suite # [REDACTED] at 10:34am on [REDACTED]. The glass measurements and the tripod with the camera recording the measurements photographed in the long IR range. Note the approx. 127 °F radiation.
