REPORT

**In-Situ Solar Heat Gain  
Coefficient (SHGC)  
Determination  
for Curtain Wall Glazing**

**[REDACTED] Tower**

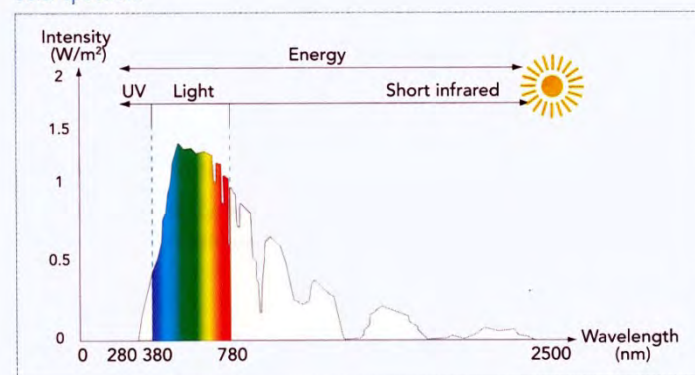
Solar spectrum

According to the European Standard EN ISO 410 cited by American NFRC standards, SHGC is the glass transmittance in range from 300nm to 2500nm, as shown on the chart below. This range embraces ultraviolet (UV) rays, visible (VIS) range, and near-infrared (NIR) range called also “solar range,” or “short infrared.

Composition of the solar spectrum

Type of radiation	Wavelength (nm)	Proportion of energy
UV	280 to 380	approx. 5 %
Visible	380 to 780	approx. 50 %
IR	780 to 2,500	approx. 45 %

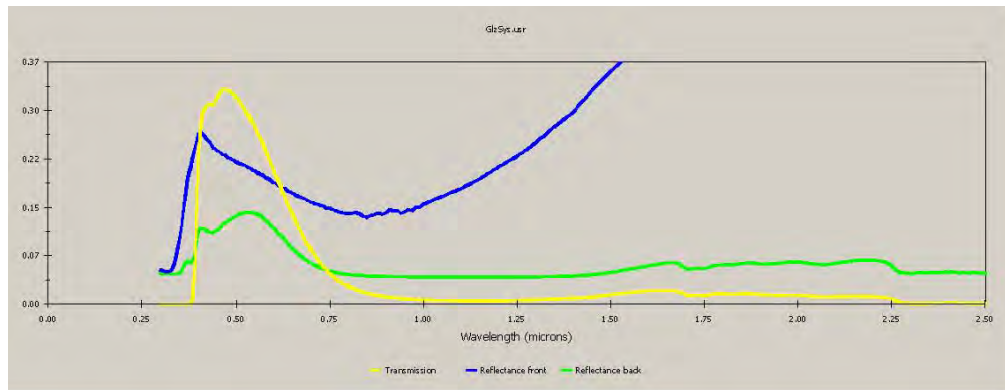
simulated the glass spectral response in Optics software by Lawrence Berkeley National Laboratory. The result is presented in the chart below.

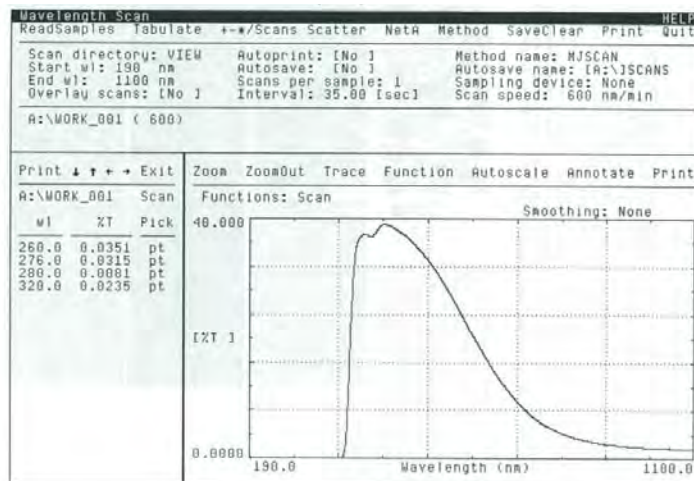
The glass samples were tested by a spectrophotometer Beckman DU 640 in range 180-1100nm and the result is presented below. Both charts are identical, with the characteristic double peak signature; therefore, we believe the glass we received is the glass specified. Flipping the glass produced an identical chart.

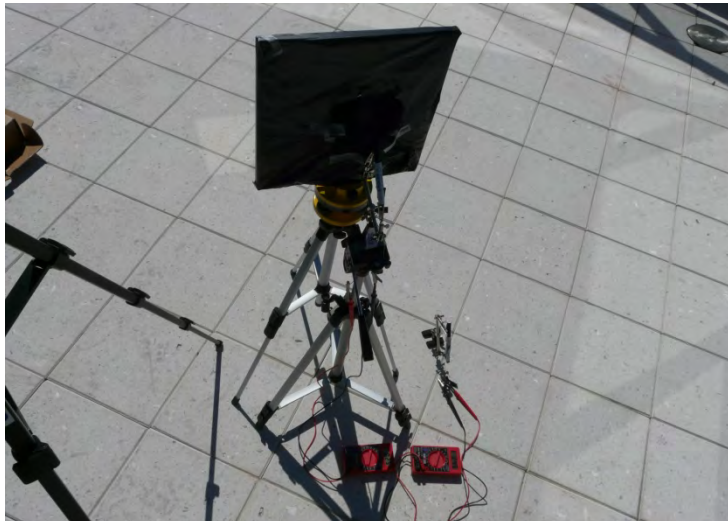
Subsequently, we noted the readings produced from our apparatus on the reference samples. We covered the entire sample with a black cover, leaving only a small hole for sunlight to get through, thus eliminating possible stray light reaching sensors. The pyranometers indicated 25/245 (10%) and pyrometer indicated 106/458 (23%).

Figure 6. The measurement of the reference sample on the 35<sup>th</sup> floor. The pyranometers read 245 (sensor in direct sun) and 25 (sensor sees the sun via the reference sample).

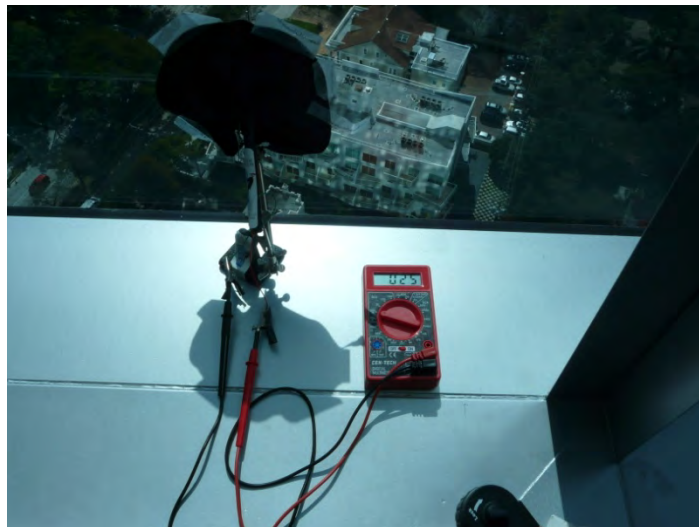
Room	Glass pane # from left to right looking out	SHGC
█	1	0.33-0.36
█	2	0.33-0.36
█	1	0.33
█	2	0.33
█	1	0.36
█	2	0.36
█	3	0.36
█	1	0.33-0.34
█	2	0.35
█	4	0.35
█	5	0.36

Figure 7. The pyranometer measuring the glass pane #2 in suite # █.

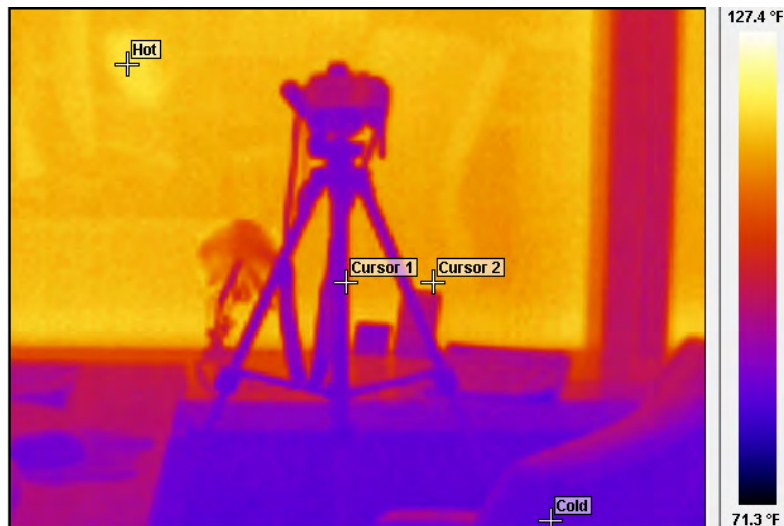
Figure 11. The suite # [REDACTED] at 10:34am on [REDACTED]. The glass measurements and the tripod with the camera recording the measurements photographed in the long IR range. Note the approx. 127 °F radiation.
